## **Chapter 2 DESCRIPTION AND TIMELINE OF THE INCIDENT**

### **2.1 INTRODUCTION**

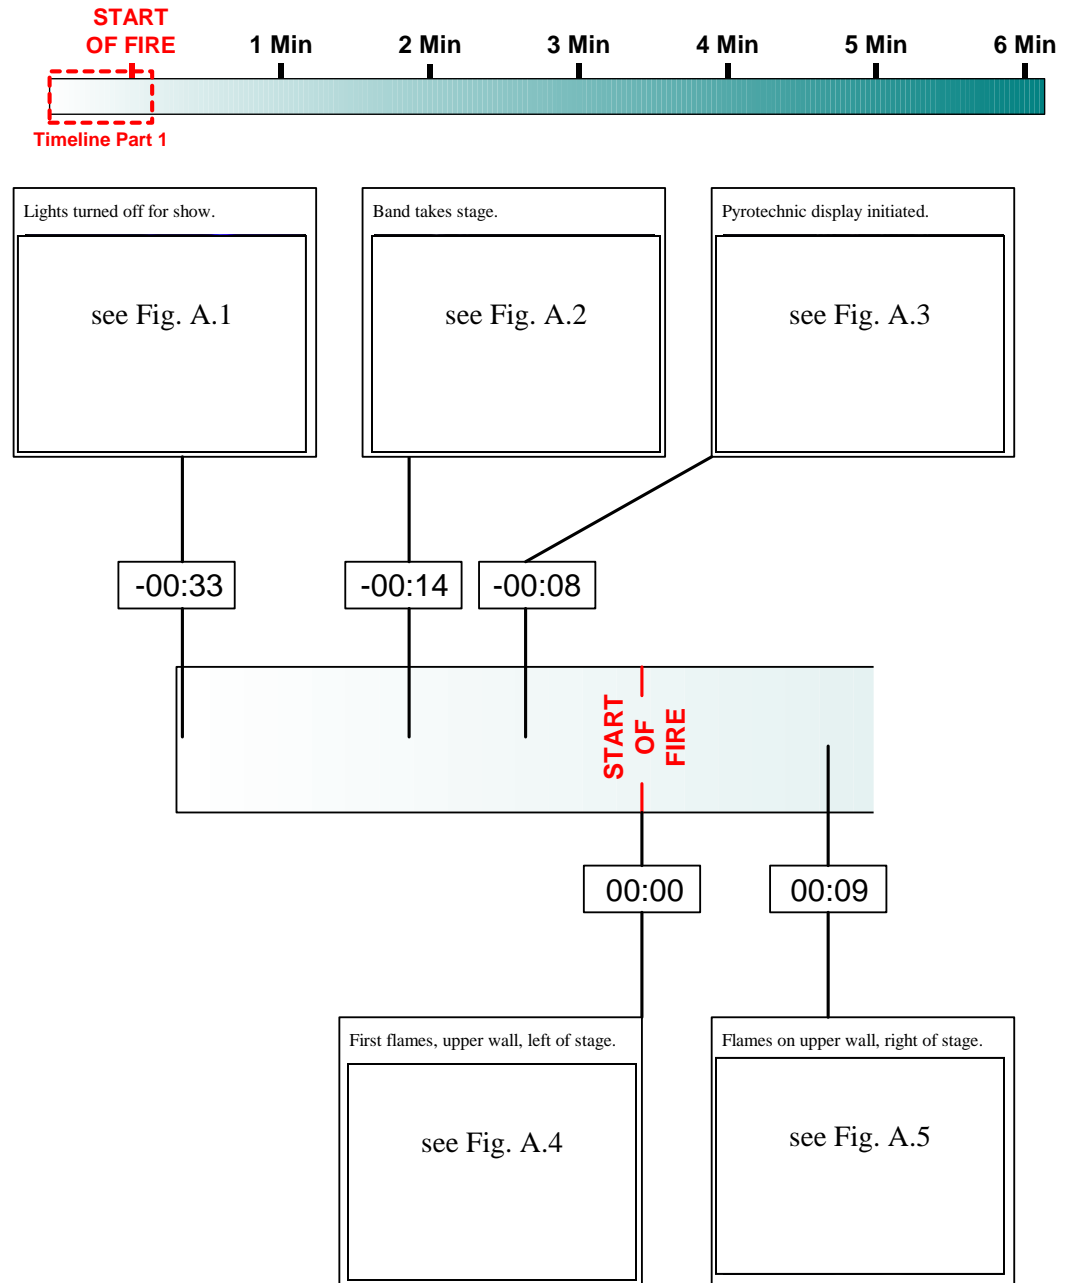
Figure 2-2a. Evacuation Timeline (33 seconds before to 10 seconds after ignition).

The focus was the time period beginning when portions of the club lights were shut down in preparation for the show, until the videographer placed the camera on the ground in the parking lot and significant flames were seen at the front of the building. The polyurethane foam along the vertical corners of the walls forming the drummers alcove ignited 8 seconds after the pyrotechnic display was initiated, as seen in Fig. 2-2a.. The videographer moved his camera aside 7 seconds later to view the growing fire along the wall better; the band members near the back of the platform noticed the flames 4 seconds later. (Refer to Fig. 2-2b.) The videographer swung his camera around and headed for the exit at the front of the building 18 seconds after ignition of the foam; the first patrons could be seen on the videotape to recognize the fire danger at 24 seconds. Around the time the band stopped playing (30 seconds fire time),

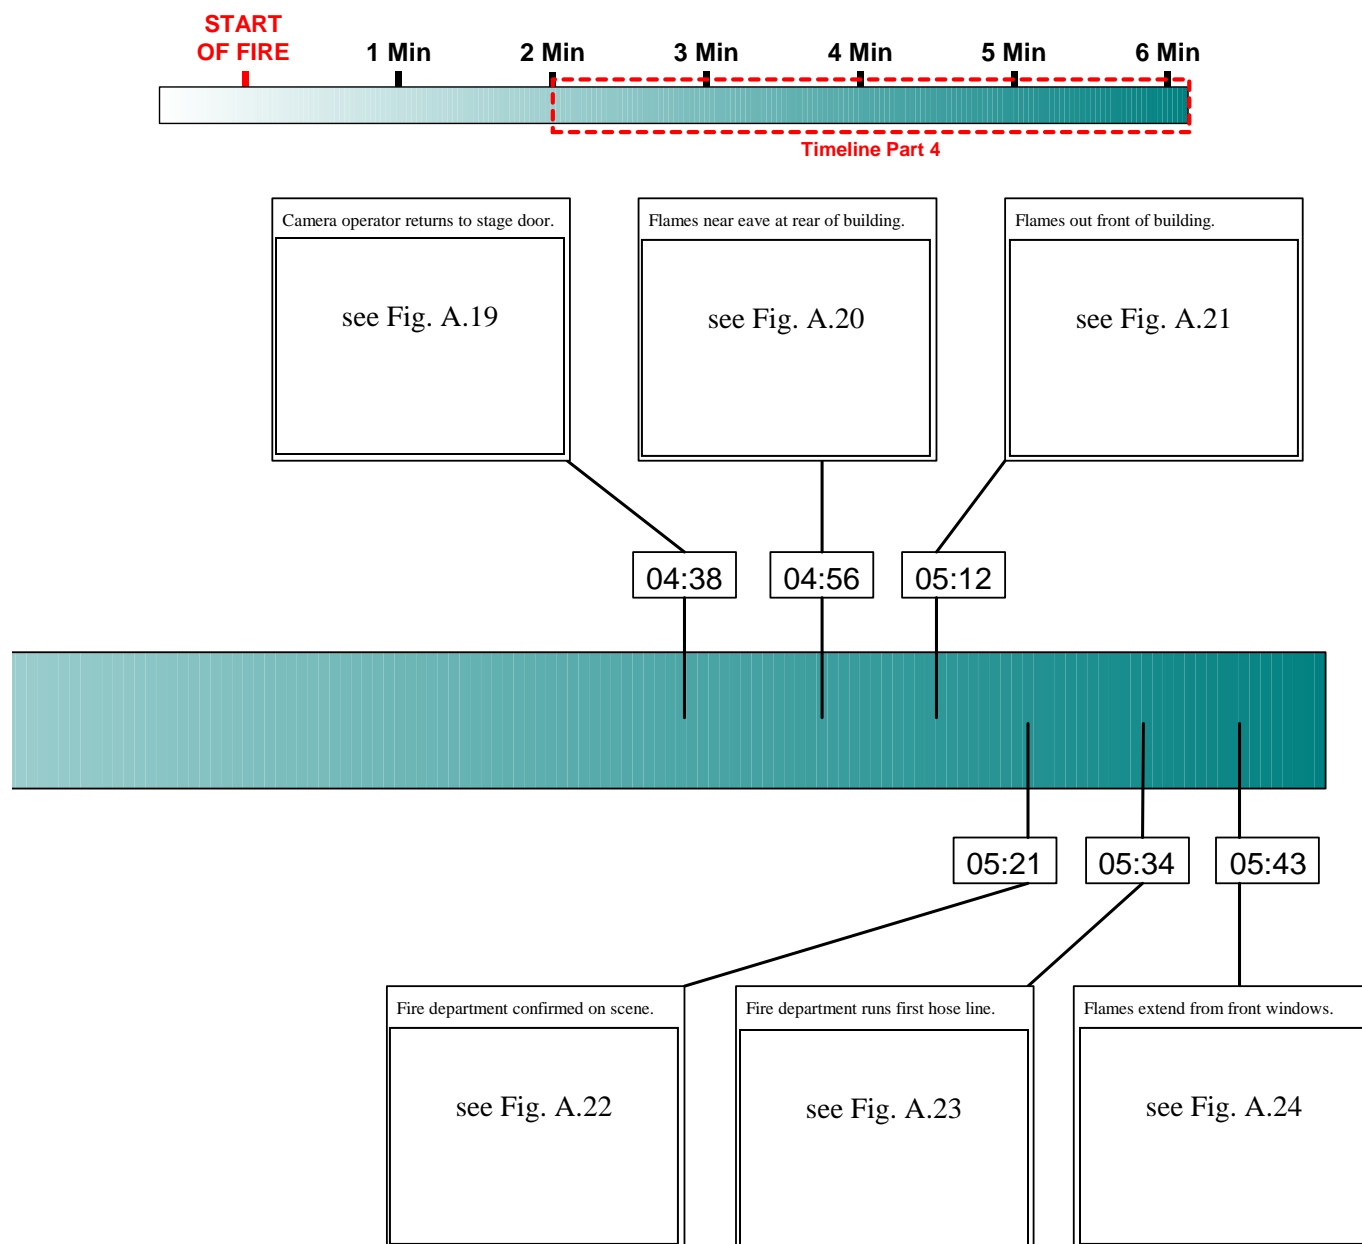
**Figure 2-2d. Incident Timeline, Part 4 (2 minutes after ignition to 5:43).**

The videographer made his way to the exit lobby while continuing to capture the movement of the crowd leaving the area around the dance floor. As seen in Fig. 2-2c, he exited the building at 1 minute 11 seconds (fire time) along with a steady stream of occupants. Sometime estimated to be around 1 minute 30 seconds after ignition of the foam, the front exit became blocked with people, and occupants could be seen breaking windows and escaping from the poolroom/sunroom. The result of the crowd crush at the front exit was captured on the video at 1 minute 42 seconds (Fig. 2-2c). The latest time recorded for an occupant escaping from inside the main bar (through a window) was at 4 minutes 8 seconds; however, people stuck in the front entrance are seen in the video to have escaped as late as 5-1/2 minutes into the fire, just before the fire department ran its first hose line (Fig. 2-2d). (One patron claimed to have been pulled from the bottom of the pile by a firefighter considerably later, but this has not been confirmed by the NIST investigation.)
